The Progressive Development and Post-failure Behaviour of Deep-seated Landslide Complexes

PhD thesis

This thesis is submitted in accordance with the regulations for the degree of Doctor of Philosophy in Durham University, Department of Geography, 2011

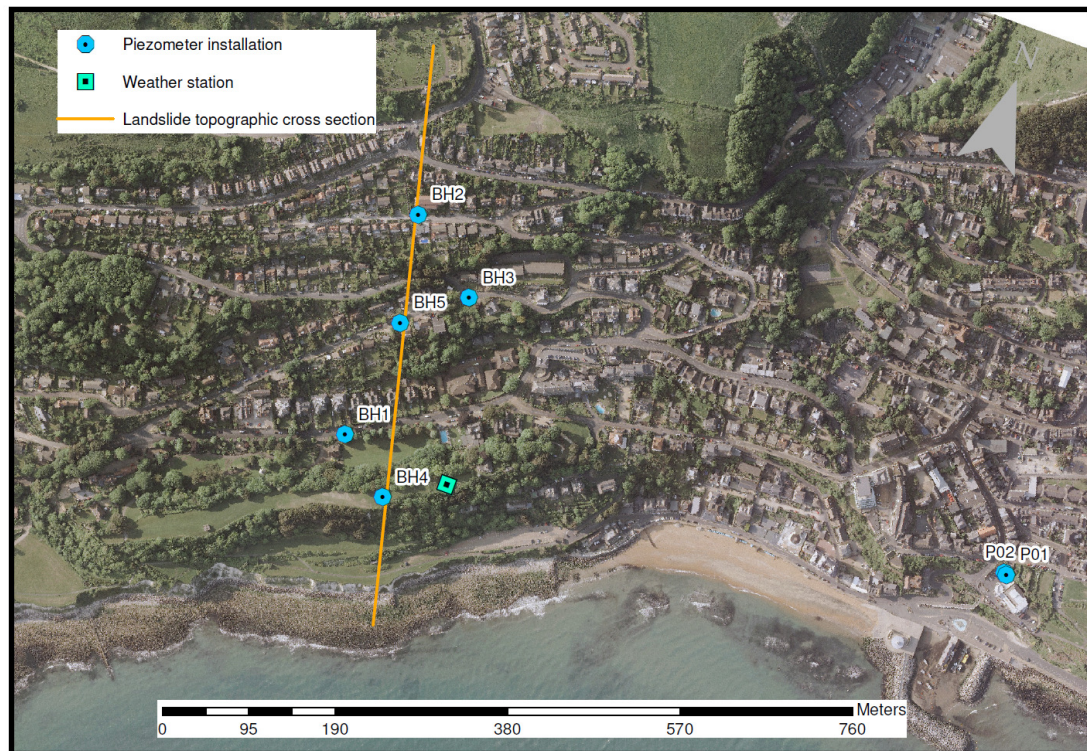
Figure 5.24 Piezometer and weather station locations, Ventnor Town
